Errata Sheet

Product Family:	DL305	Date:	10/14/2021
Manual Number	D3-350-M		
Revision and Date	2nd Edition, Rev. D; March 2010

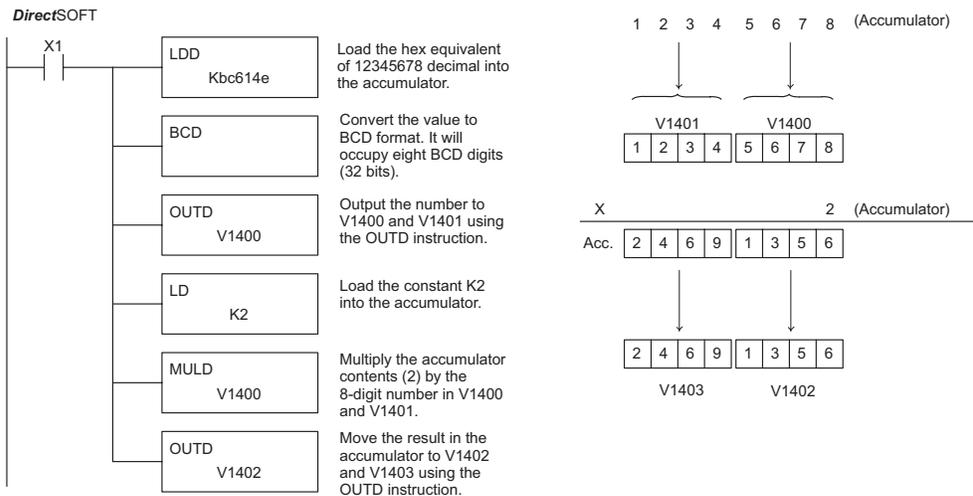
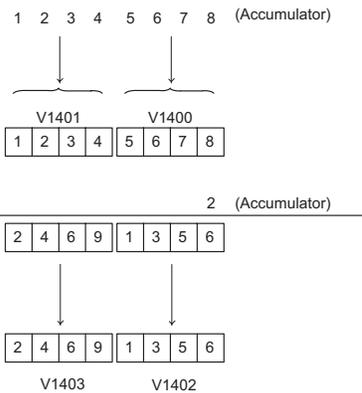
Changes to Chapter 5. Standard RLL Instructions; Math Instructions; Multiply Double (MULD)

Page 5-84. The ladder example shown is incorrect. Replace it with the following example.

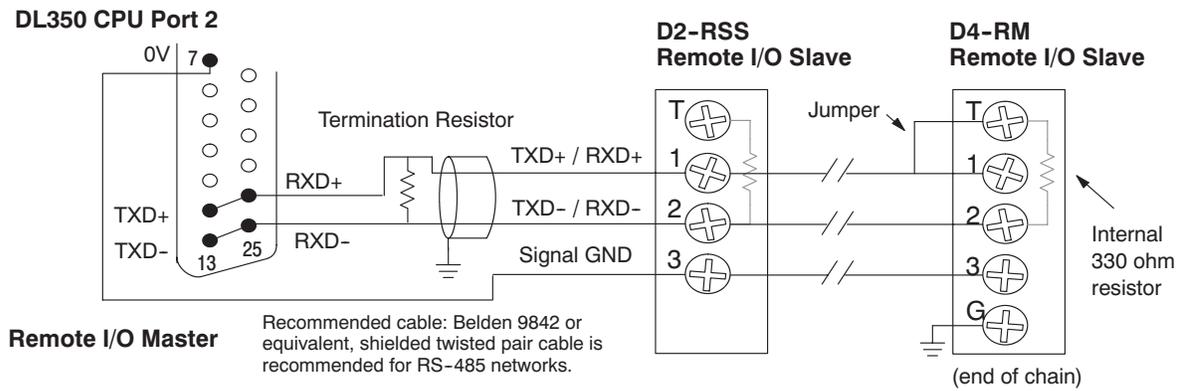
Page 4-18. CPU Specifications; Remote I/O Expansion; Configuring the CPU's Remote I/O Channel

Replace the remote I/O wiring diagram shown with this one.
