Errata Sheet

Product Family: DL305 **Date:** August 2018
Manual Number: D3-350-M
Revision and Date: 2nd Edition, Rev. D; March 2010

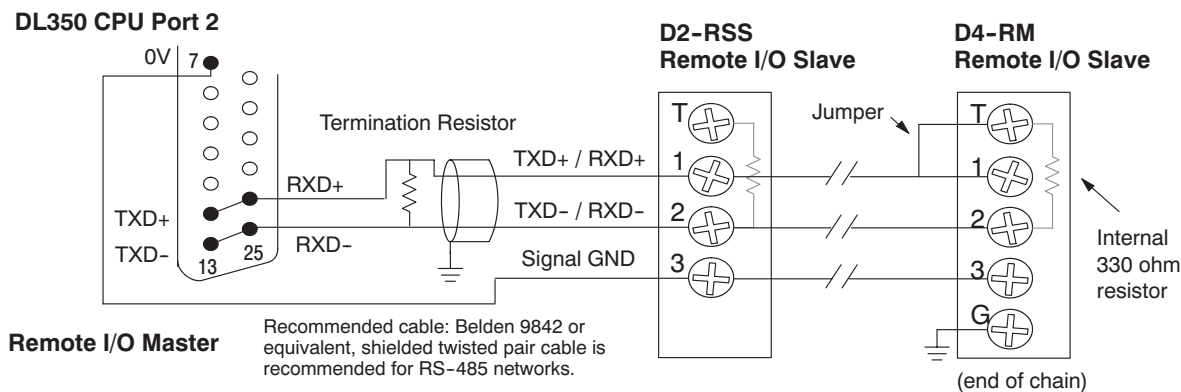
Page 4-18. CPU Specifications; Remote I/O Expansion; Configuring the CPU's Remote I/O Channel

Replace the remote I/O wiring diagram shown with this one.

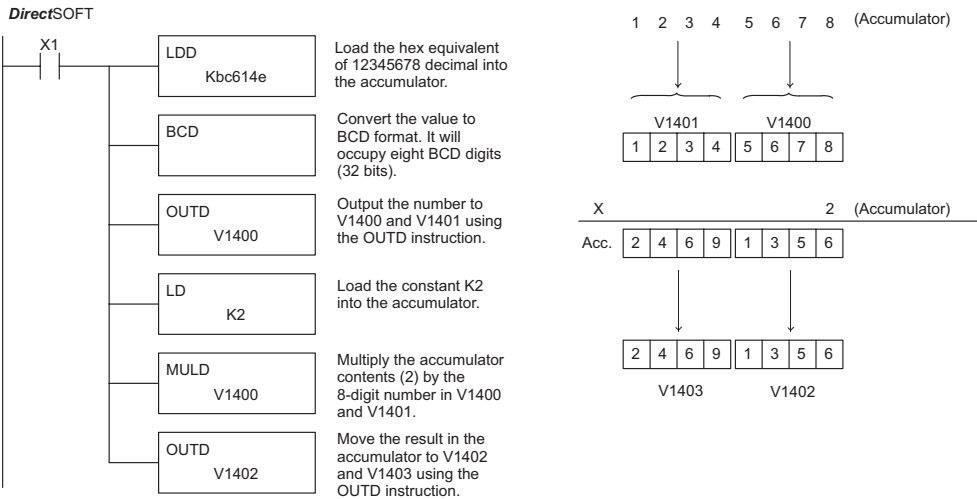
Changes to Chapter 5. Standard RLL Instructions; Math Instructions; Multiply Double (MULD)

Page 5-84. The ladder example shown is incorrect. Replace it with the following example.
