Product Family: DL305 Date: 12.04.2023

Manual Number D3-USER-M

Revision and Date 1st Edition, Rev. D; January 2010

DL305 User Manual Errata

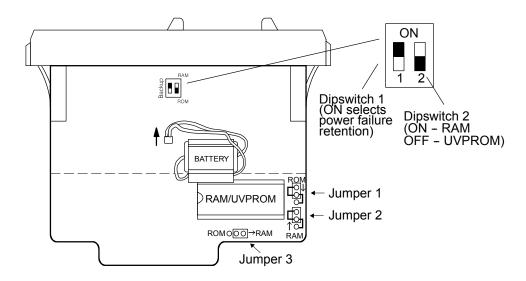
Page 3-9. DL330/DL330P CPU Setup; Installing the UVPROM Option in the DL330/DL330P CPU.

The drawing showing the jumpers is missing the silkscreen jumper lines and arrows for jumpers 1, 2, and 3. Refer to this drawing.

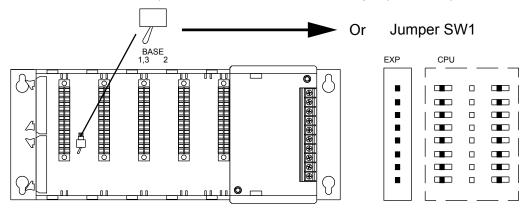
Page 4-16. Setting the Base Switches; 5 Slot Bases:

Replace the drawing of the 5 slot base with this one. Newer 5 slot bases have jumper switch SW1 instead of the toggle switch to set whether the base is a local CPU base or an expansion base.

NOTE: Older bases have a toggle switch to set the base as the CPU local base, the first expansion base, or the second (last) espansion base. Newer bases have the jumper SW1 in place of the switch.
