# Troubleshooting the OP-1212 Panel

**Troubleshooting** This section is intended to help you through some typical situations that might occur while using the OP-1212. It is difficult to diagnose or solve all probable situations that may arise, therefore this section will discuss some of the more common trouble areas.

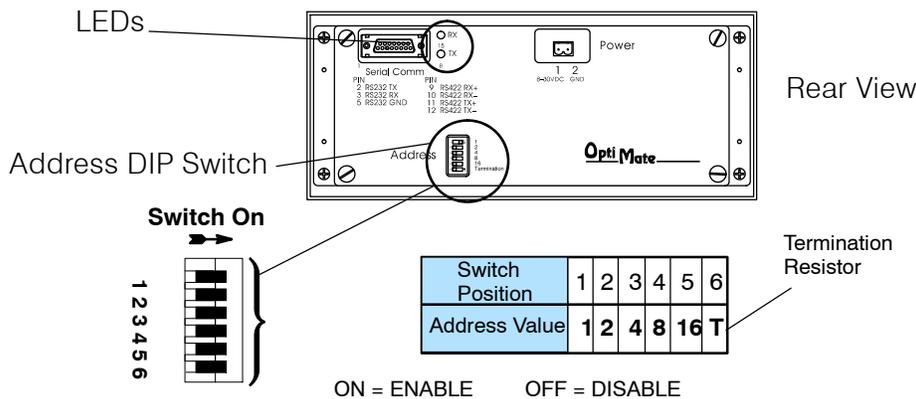
- Examine the two LEDs on the rear of the panel that show the state of the communication link. If the RX LED blinks but the TX LED does not, verify that you are using the appropriate cables.

- If the RX LED does not blink, the communication cable is plugged into the wrong serial port of the PC, the cable is faulty, or the panel is faulty.
- If the TX LED and/or the RX LED is blinking very slowly while you are attempting to download and all of the Lamps and LEDs are blinking, verify that the panel address is set to 31 (all positions ON) and power cycle the panel.

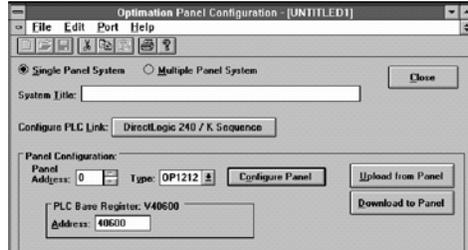
- Observe the TX and RX LEDs on the rear of the panel. If the TX LED flashes but the RX does not, check all cables and connections and try again.
- Examine the configuration and verify the Link and Comm. information match the PLC type and family that you are using (i.e. baud rate, parity, stop bit, address).

- If you are using the secondary comm port on a **Direct**LOGIC PLC and both TX and RX LEDs are flashing verify the mode of that port is set to HEX and not ASCII.
- If you are using a Allen-Bradley PLC, verify that the baud rate for channel 0 is set to 4800 or 9600 and the memory map has been expanded to include the full range of registers (i.e., N7:0 through N7:7).

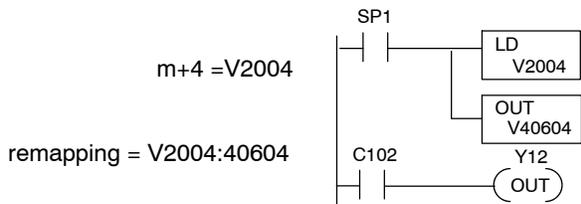
- If you are remapping, make sure that you are remapping in the proper direction and that you are using a contact that is always ON as the input to the remapping logic. Remapping must be performed every scan to function properly.

Here we are using SP1 to map V2004 to V40604. This consumes 16 relay bits, 12 of which are tied to the 12 pushbuttons of the panel. By pressing Pushbutton 3, you affect the status of the third relay in V40604 which is C102. In turn, C102 will control output Y12.

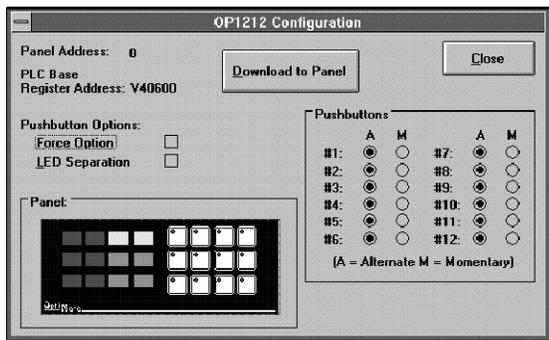
- If the LED Separation Mode was enabled, the LED will work independently of the pushbutton. In this case the LED will be turned ON by the ladder logic program.
- The pushbutton may be configured as momentary. In this case the LED will be ON only as long as the pushbutton is being pressed.
