Maintenance and Troubleshooting

Troubleshooting the OP-1500/1510 Panels

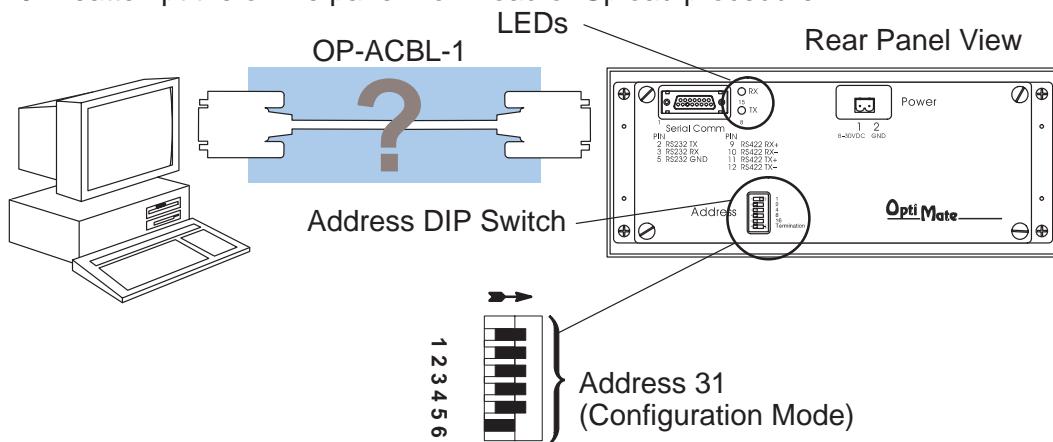
1. Check the rear panel RX/TX LEDs while attempting the Upload or Download operation. If the LEDs (RX/TX) are slow alternating flash signals, the PC and OP are connected. If *only* the TX (transmitter) LED is flashing, or the TX/RX are *not* alternating between flashes, verify the OP-panel is set to address 31 (Configuration Mode).
2. Check and verify the configuration cable (**OP-ACBL-1**) is properly connected. For cable details, refer to Chapter 2, the Cable Specification section.
3. Ensure configuration mode is selected, by setting all *address* switches to the ON position (Address 31).
4. Ensure the correct communications port is selected with the software, such as COM1, COM2, COM3, COM4.
5. Check 24VDC power source.
6. Reattempt the online panel Download or Upload procedure.

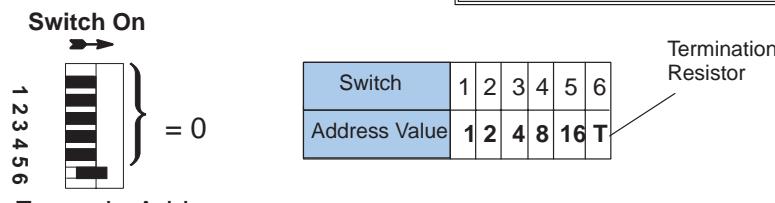
Example Address

2. Examine Address switches to ensure correct address selection (valid settings 0 – 30). You must cycle OP-panel power for address switch changes to take effect.
3. Examine the communications information for the PLC type, protocol type, baud rate, parity, stop bit, address number. Use the respective user manuals for the PLC product you are using to determine the proper settings.
4. If you are using an OP cable, verify cable pinout. For RS422 connections use a Belden 9279 or equivalent cable.
5. Check 24VDC power source.

1. Observe the TX and RX LEDs on the rear of the panel. If both LEDs are not a steady flash or glow (depending on baud rate) check and ensure the proper communications cable is securely connected.
