Troubleshooting the OP-609

Troubleshooting the OP-609 Panel

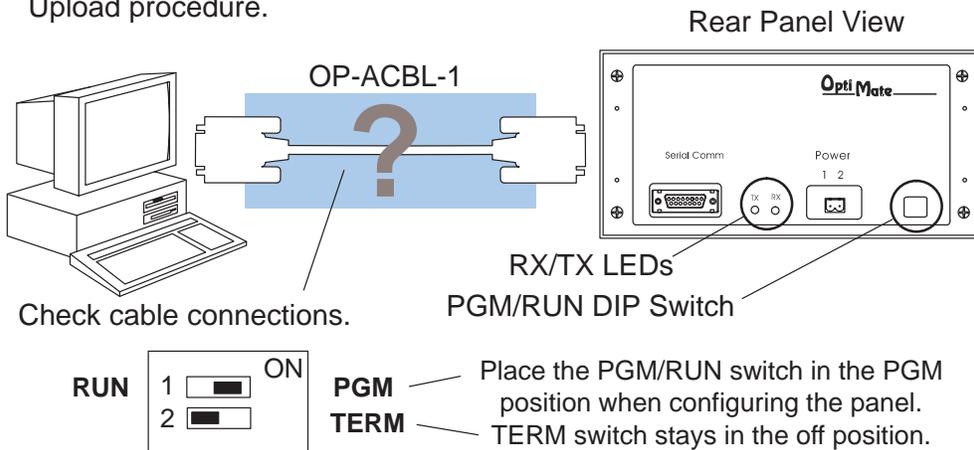
1. Check the rear panel RX/TX LEDs while attempting the Upload or Download operation. Both LEDs should be giving slow alternating flash signals, indicating the PC and OP-panel are connected. If *only* the TX (transmitter) LED is flashing, or if the TX/RX LEDs are *not* alternating between flashes, check that the OP-panel is set to the configuration mode by setting the RUN/PGM DIP switch to the PGM position. Remember to cycle the power.

4. Check the 24VDC power source and connections.
5. After checking the above items, repeat the online panel Download or Upload procedure.
