Appendix B

Troubleshooting the OP-620

Troubleshooting the OP-620 Panel

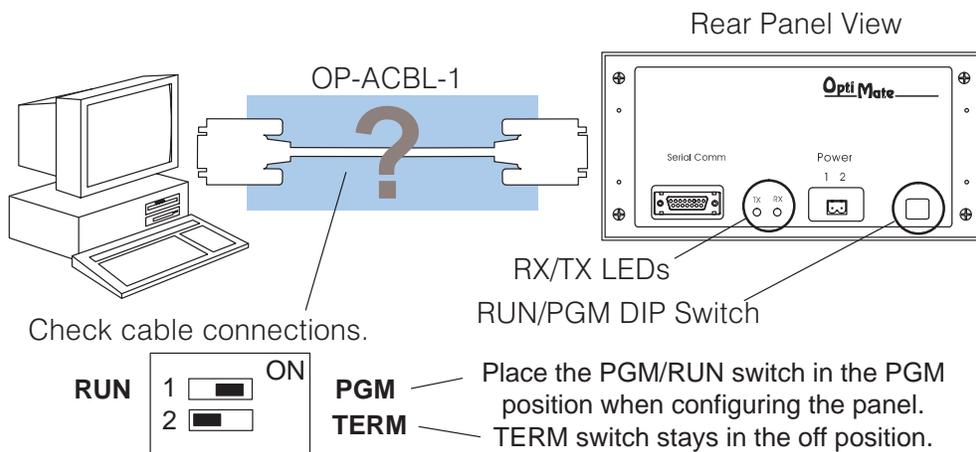
1. Check the rear panel RX/TX LEDs while attempting the Upload or Download operation. Both LEDs should be giving slow alternating flash signals, indicating the PC and OP-panel are connected. If *only* the TX (transmitter) LED is flashing, or if the TX/RX LEDs are *not* alternating between flashes, check that the OP-panel is set to the configuration mode by setting the RUN/PGM DIP switch to the PGM position.
2. Check to make sure the configuration cable (**OP-ACBL-1**) is properly connected. For cable details, refer to the Appendix A, Connecting the Configuration Cable OP-ACBL-1 section.
3. Make sure the correct communications port is selected with the software, such as COM1, COM2, COM3, COM4.
4. Check the 24VDC power source and connections.
5. After checking the above items, repeat the online panel Download or Upload procedure.

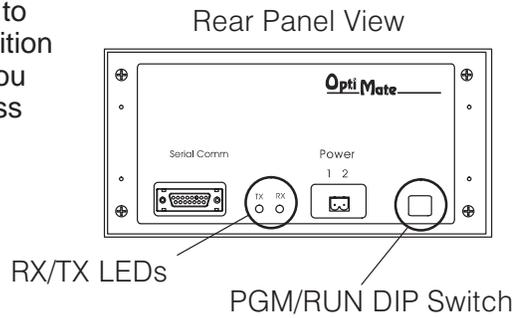
1. Observe the TX and RX LEDs on the rear of the panel. Both LEDs should be a steady flash or glow (depending on baud rate). If not, check and make sure you are using the proper communications cable and that it is securely connected.
2. Examine the PGM/RUN DIP switch to make sure it is placed in the RUN position to load and run the ladder program. You must cycle OP-panel power for address switch changes to take effect.

Place the PGM/RUN switch in the RUN position when running the program.
